STUDIES IN CAN GIO MANGROVE BIOSPHERE RESERVE, HO CHI MINH CITY, VIET NAM

Monitoring Riverbank Erosion in Can Gio Mangroves

Huynh Duc Hoan, Bui Nguyen The Kiet, Cao Huy Binh & Pham Van Quy

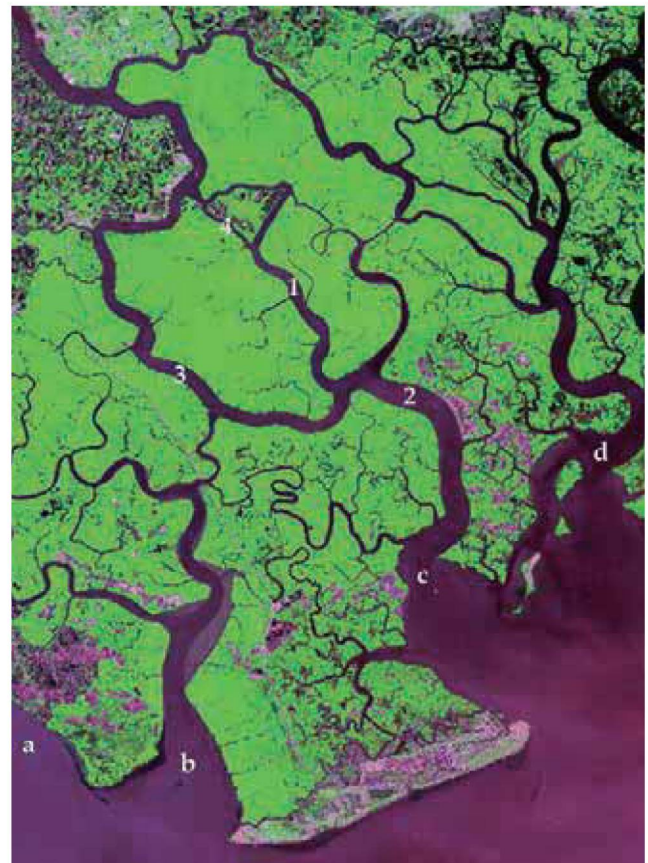
Figure 1 Major rivers of Can Gio mangroves and rivers where riverbank erosion was monitored

Estuaries of major rivers

(a: Soai Rap, b: Dong Tranh, c: Nga Bay and d: Thi Vai)

Study sites

(1: Dua, 2: Nga Bay, 3: Long Tau and 4: Tac Roi)

Four major rivers and their tributaries traverse the Can Gio mangroves before draining into the East Sea. They are Soai Rap, Dong Tranh, Nga Bay and Thi Vai (Figure 1). Together they cover an area of 22,160 ha or ~20% of the Can Gio district. These large rivers together with small ones such as Long Tau are the main shipping lanes, enabling cargo tankers and ships of up to 20,000 tonnes carrying capacity to enter into the port of Ho Chi Minh City (HCMC) (Luong, 2011).

Satellite imageries and maps from previous years of Can Gio were collected for data analysis. The rivers studied were Dua, Nga Bay, Long Tau and Tac Roi (Figure 1). In the field, bamboo stakes were piled into

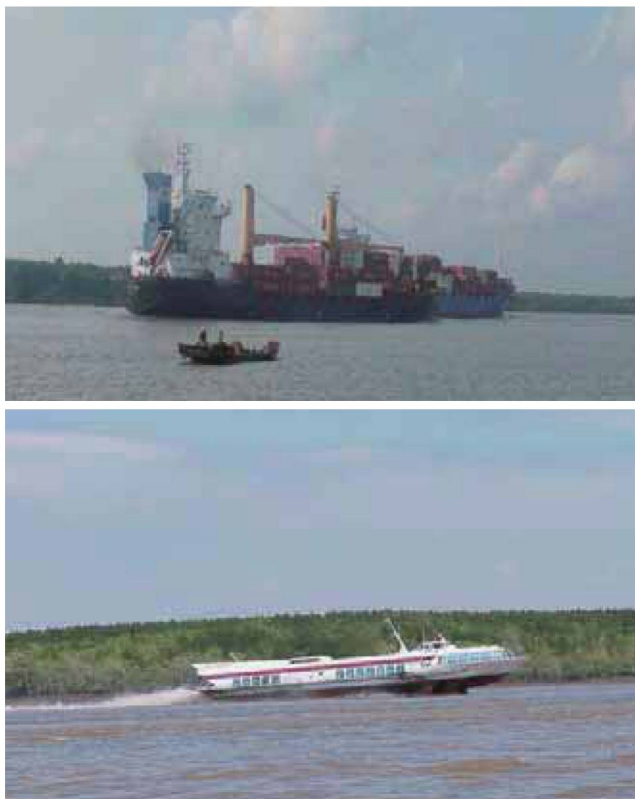
Figure 4 Cargo ships (top) and passenger speedboat (bottom) using the Can Gio rivers

(Table 1). Long Tau and Nga Bay rivers had the most number of stakes as they are two major waterways used by cargo tankers and ships to reach the port of HCMC (Figure 4). Dua and Tac Roi rivers are smaller rivers used mainly by passenger speedboats commuting between Vung Tau and HCMC.

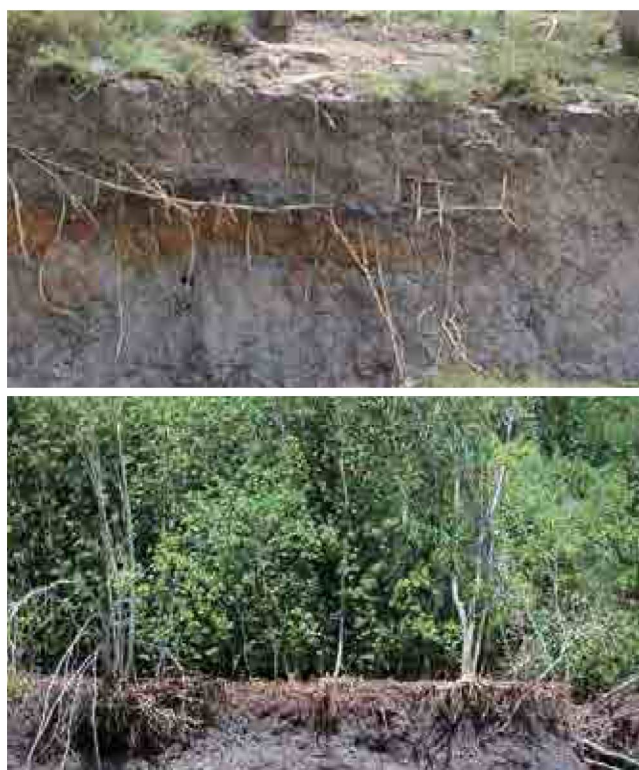
Figure 5 Erosion of riverbanks without vegetation (top) and with vegetation (bottom)

Data showed that the erosion rates of plots with forests were less severe than plots located on bare land (Table 3). Examples of erosion of riverbanks with and without vegetation are shown in Figure 5.
